**Flood Control Project Maintenance
Levee Inspections**

Maintenance Issue Types Only, Levee Inspection Report By Mile - Spring 2019

Reclamation District No. 0010 Honcut

Waterway	Bank	Unit Miles	Inspection Start/End	Inspector
Unit No. 01 Simmerly Slough	Right	7.65	05/16/2019 05/16/2019	Sterling York

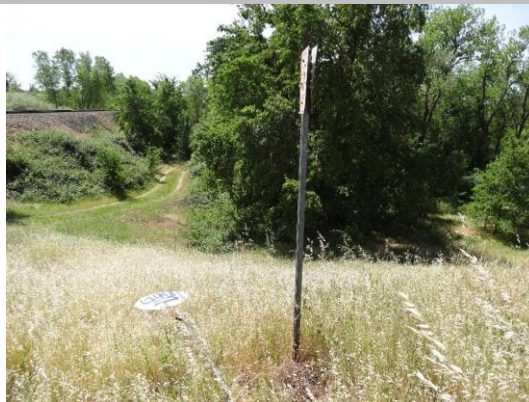
Photo 2 of 3 : UCIP_SP_2019_27791_51500.jpg

Pipe marker visible on ground--sign has been bent.

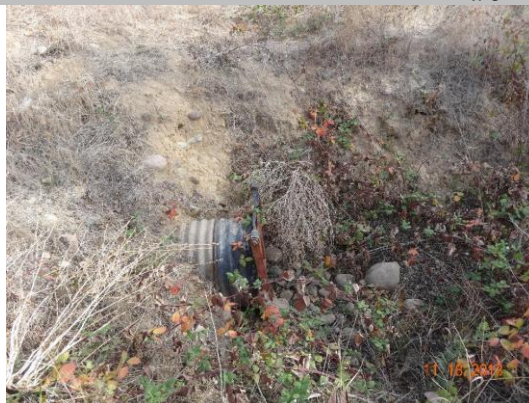
Photo 3 of 3 : UCIP_SP_2019_27791_51504.jpg

Comment Code						
Inspector Comment						
FS_ID:27791 DS_ID:21268 EP_NO: N/A Repair Type: Non-Urgent Crossing Status: Found UCIP Comments: 04/29/2013 Vegetation has been cleared from slope. This crossing is referenced in the USACE Periodic Inspection as item USACE_CESPK_HON1_2013_p_0158. (DWR UCIP - O. Magana) FIELD_STRUCT_DESC: 24-inch corrugated metal gravity drainage pipe through the levee, 30 feet below the crown. Flap gate on the waterside (WS) end. Slide gate on the landside (LS) end. Concrete saddle and apron on the WS. [Additional Reference(s): DWR Levee Log, 2005. USACE Sacramento O&M Manual 151, May 1953, (Station 1+00)]. FS Date: 4/29/2013

View of pipe and flap gate located on waterward side.

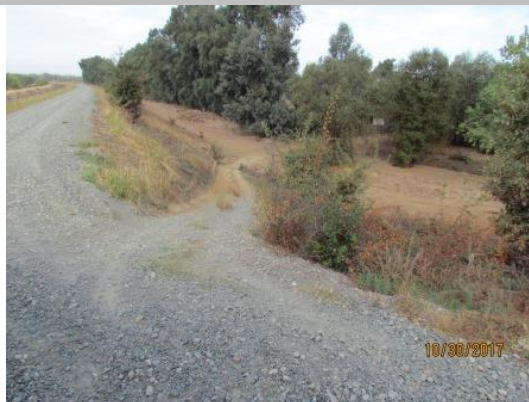
Photo 1 of 1 : SP_2019_RD0010_163_48_20190305_00009.jpg

LM Start	0.72	Rating **	M	Issue No.	48
LM End	0.72	Issue Type +	Ma	Location *	LS
Category	Earthen Levee			GPS Latitude/Longitude	
				Start	End
Item	Slope Stability			39.161198 °	39.161198 °
				-121.597102 °	-121.597102 °
DWR ID	DWR_RD0010_01_f_2013_48				
Comment Code					
S3 : Repair the levee slope damaged by vehicle traffic and prevent access where possible.					
Inspector Comment					
Ramp is caused by constant ATV foot traffic use on levee slope.

View of the slope stability caused by foot traffic on the landward side of the levee looking downstream.

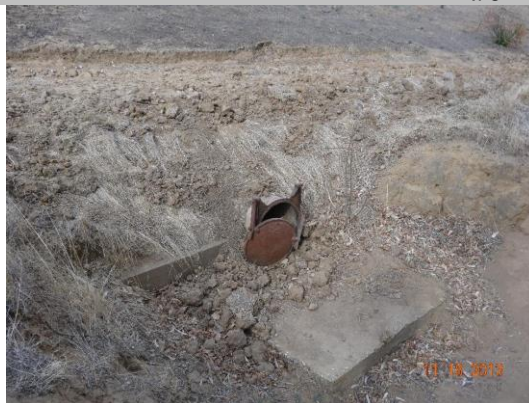
Photo 3 of 3 : UCIP_SP_2019_50058_51414.jpg

Comment Code						
Inspector Comment						
FS_ID:50058 DS_ID:21258 EP_NO: N/A Repair Type: Non-Urgent Crossing Status: Found UCIP Comments: 7/01/2016 Gate has been repaired--WS gate is functional. LS gate still needs new stem for the gate to properly function--stem is bent. USACE's PI issue references permit number 13710 this is incorrect permit is associated with DS_ID 21259 (CLM 0.767). (DWR UCIP - omagana)4/29/2013 Damaged flap gate on waterward side and damaged stem on screw gate on landward side. Need to contact owner to determine if crossing is still active. If crossing is still in use owner will need to address damage on flap gate and screw gate. If crossing is no longer in use owner will need to contact the CVFPB to comply with Title 23. This crossing is referenced in the USACE Periodic Inspection as item USACE_CESPK_HON1_2013_p_0053 and 0057. (DWR UCIP - omagana) FIELD_STRUCT_DESC: 24-inch corrugated metal gravity drainage pipe through the levee, 31 feet below the crown. Two corrugated metal cutoff walls around pipe. Concrete headwall at each end. Flap gate on the waterside (WS) end. Slide gate on the landside (LS) end. Pipe discharges into 6-foot concrete splash apron on the WS. [Additional Reference(s): DWR Levee Log, 2005. USACE Sacramento O&M Manual 151, May 1953, (Station 46+60)]. FS Date: 7/1/2016

Damage flap gate located on WS.

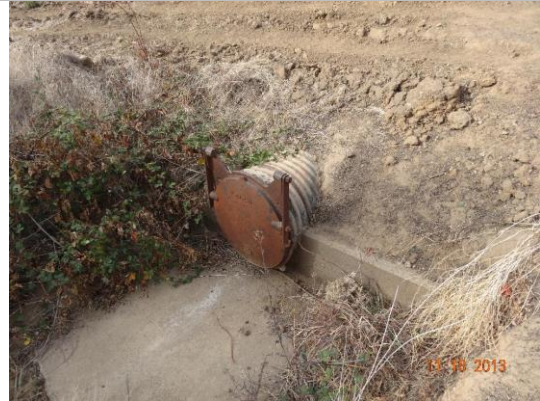
Photo 2 of 3 : UCIP_SP_2019_53136_44587.jpg

View of headwall, pipe, and flap gate located on WS.

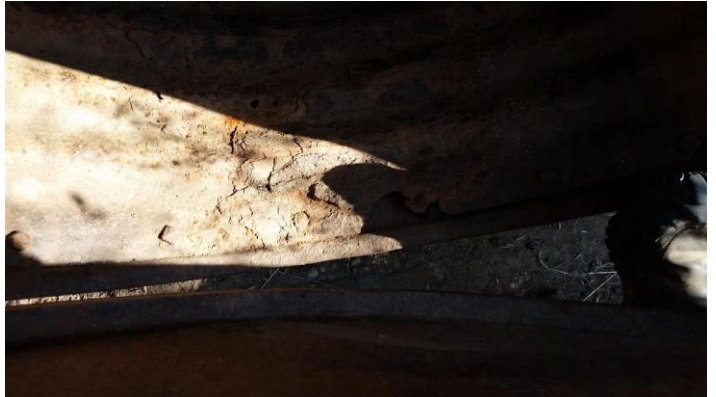
Photo 3 of 3 : UCIP_SP_2019_53136_75321.jpg

Comment Code						
Inspector Comment						
FS_ID:53136 DS_ID:21318 EP_NO: N/A Repair Type: Urgent Crossing Status: Found UCIP Comments: 10/18/2018 No change since the last inspection. Pipe remains Urgent due to deteriorated wall (visible holes present inside) near WS flap gate. This pipe is part of DWR's Deferred Maintenance Project (DMP). According to LMA representative, the video inspection of DMP pipes is expected to be completed next year. Levee height is about 25-30 feet. (O. Magana - DWR UCIP)7/01/2016 Pipe wall in poor condition--deteriorated pipe wall indicated by holes at the inlet and outlet pipe collar. Recommend internal integrity inspection of the pipe through the levee to determine extent of damage. (DWR UCIP - omagana)4/29/2013 Holes present on pipe wall. Need to contact owner to notify of issue with pipe. Also need to contact DWR Inspector and CVFPB to determine how to address issue. This crossing is referenced in the USACE Periodic Inspection as item USACE_CESPK_HON1_2013_p_0140. Pipe should be 30-inch instead of 36-inch mentioned Periodic Inspection. (DWR UCIP - omagana) FIELD_STRUCT_DESC: 30-inch corrugated metal gravity drainage pipe through the levee, approximately 30 feet below the crown. Two corrugated metal cutoff walls around the pipe on each side. Saddle and splash apron at the waterside (WS) discharge point. Concrete headwall and sluice gate on the landside (LS). [Additional Reference(s): DWR Levee Log, 2005. USACE Sacramento O&M Manual 151, May 1953, (Station 10+38)]. FS Date: 10/18/2018

Deteriorated pipe wall at the outlet (WS).

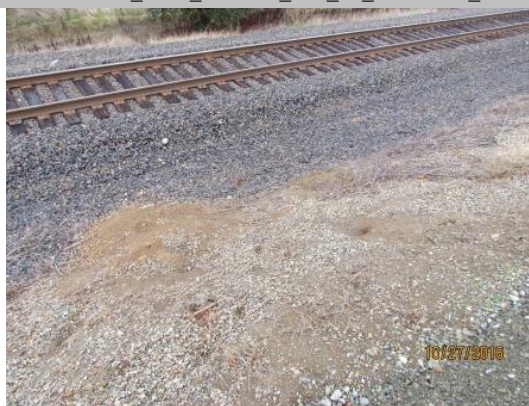
Photo 1 of 1 : SP_2019_RD0010_163_65_20190305_00021.jpg

View of squirrel holes on the landside, no rodent activity was observed.

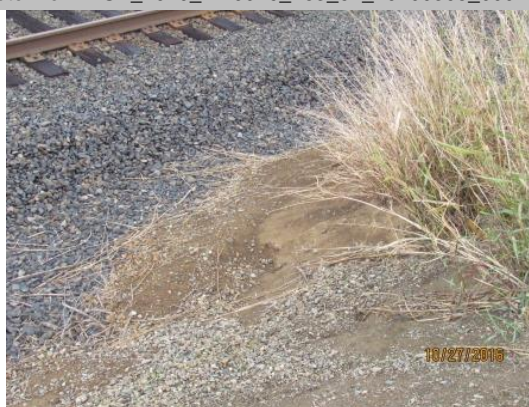
Photo 1 of 1 : SP_2019_RD0010_163_64_20190305_00020.jpg

LM Start	1.81	Rating **	M	Issue No.	64
LM End	1.81	Issue Type +	Ma	Location *	LS
Category	Earthen Levee			GPS Latitude/Longitude	
				Start	End
Item	Animal Control			39.172094 °	39.172094 °
				-121.585472 °	-121.585472 °
DWR ID	DWR_RD0010_01_s_2016_64				
Comment Code					
A3 : No rodents visible, but rodent burrows visible; need to backfill and compact or grout burrows.					
Inspector Comment					
Squirrel holes still are visible but there is no sign of activity, Spring 2019.

View of squirrel holes on the landside, no rodent activity was observed.

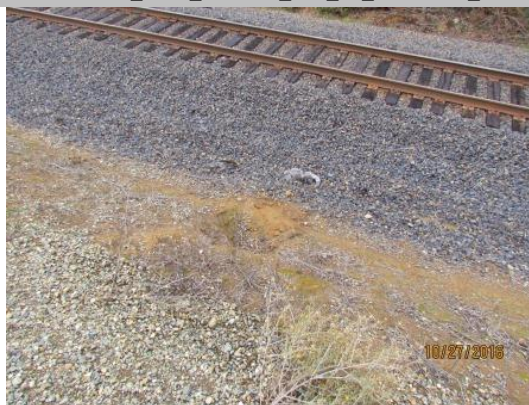
Photo 1 of 1 : SP_2019_RD0010_163_63_20190305_00019.jpg

LM Start	2.09	Rating **	M	Issue No.	63
LM End	2.09	Issue Type +	Ma	Location *	LS
Category	Earthen Levee			GPS Latitude/Longitude	
				Start	End
Item	Animal Control			39.176153 °	39.176153 °
				-121.584958 °	-121.584958 °
DWR ID	DWR_RD0010_01_s_2016_63				
Comment Code					
A3 : No rodents visible, but rodent burrows visible; need to backfill and compact or grout burrows.					
Inspector Comment					
Squirrel holes still are visible but there is no sign of activity, Spring 2019.

View of squirrel holes on the landside, no rodent activity was observed.

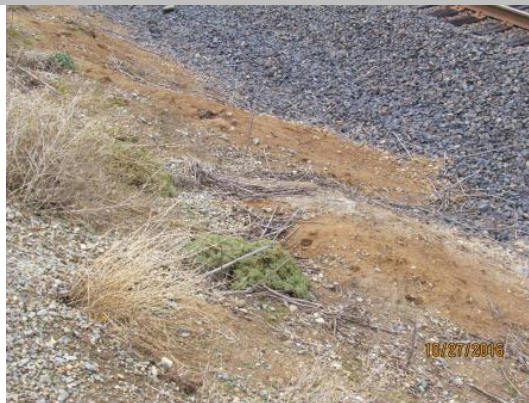
Photo 1 of 1 : SP_2019_RD0010_163_61_20190305_00018.jpg

View of squirrel holes on the landside slope and toe, no rodent activity was observed.

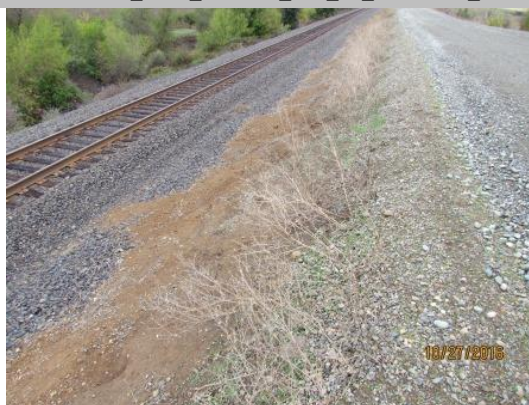
Photo 1 of 1 : SP_2019_RD0010_163_60_20190305_00017.jpg

View of squirrel holes on the landside slope and toe, no rodent activity was observed.

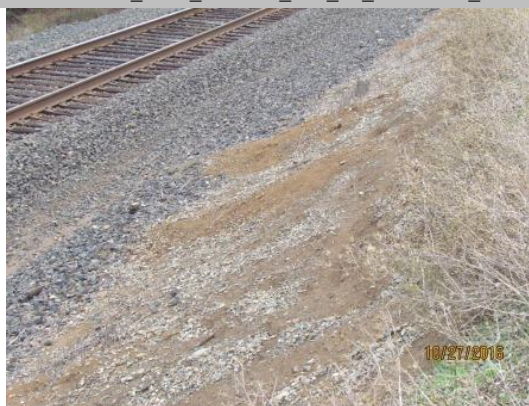
Photo 1 of 1 : SP_2019_RD0010_163_59_20190305_00016.jpg

View of squirrel holes on the landside slope and toe, no rodent activity was observed.

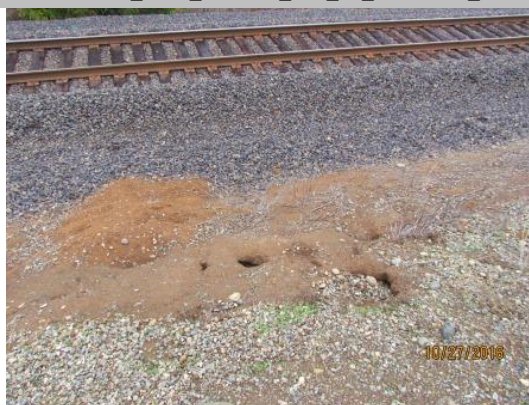
Photo 1 of 1 : SP_2019_RD0010_163_58_20190305_00015.jpg

View of squirrel holes on the landside slope and toe, no rodent activity was observed.

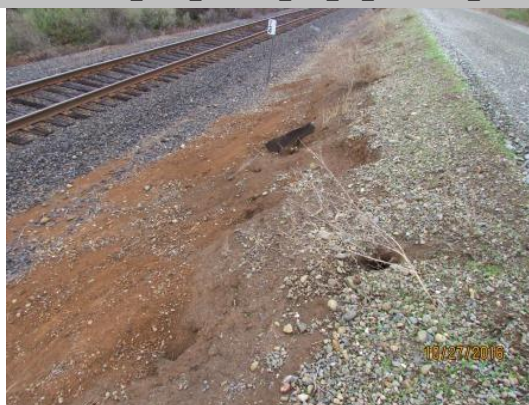
Photo 1 of 1 : SP_2019_RD0010_163_57_20190305_00014.jpg

View of squirrel holes on the landside slope and toe, no rodent activity was observed.

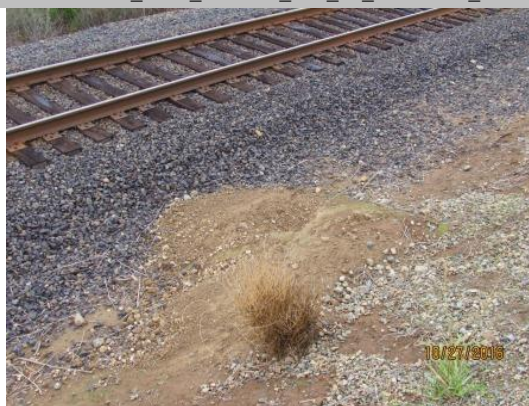
Photo 1 of 1 : SP_2019_RD0010_163_52_20190305_00013.jpg

View of squirrel holes on the landside slope and toe, no rodent activity was observed. Fall 2016.

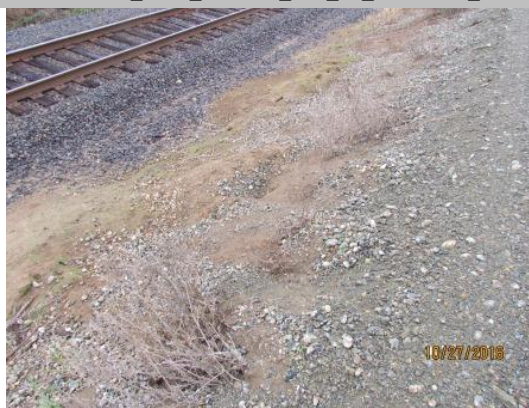
Photo 1 of 1 : SP_2019_RD0010_163_50_20190305_00011.jpg

View of squirrel holes on the landside slope and toe, no rodent activity was observed.

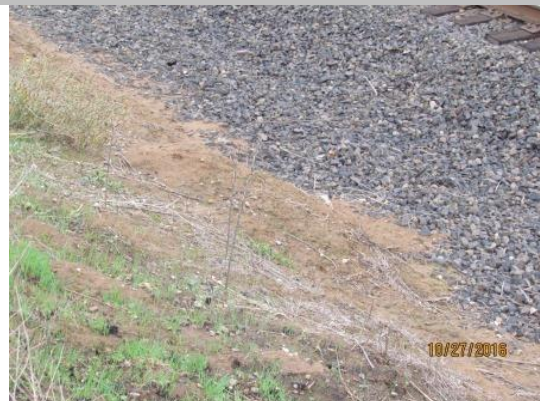
Photo 1 of 1 : SP_2019_RD0010_163_46_20190305_00007.jpg

View of squirrel holes on the landside slope and toe, no rodent activity was observed.

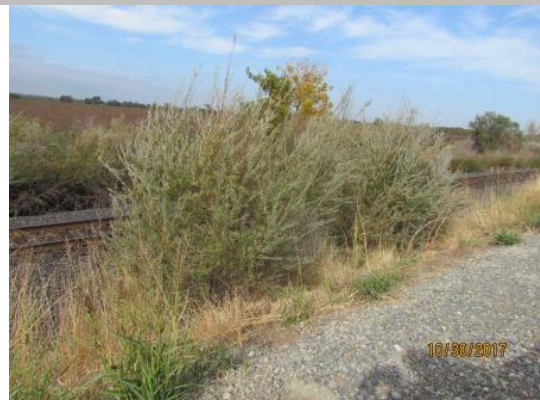
Photo 1 of 1 : SP_2019_RD0010_163_37_20190305_00003.jpg

View of small willow trees on the landside slope looking upstream.

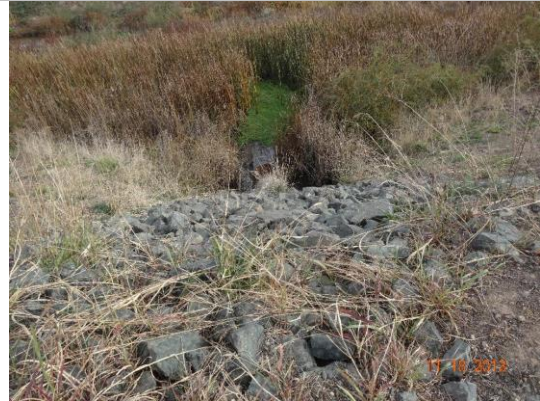
Photo 3 of 3 : UCIP_SP_2019_53138_44810.jpg

FS_ID:53138
DS_ID:21275
EP_NO: N/A
Repair Type: Urgent
Crossing Status: Found
UCIP Comments: 10/18/2018 According to the LMA representative, a small pipe repair was completed near the WS gate (pipe was leaking at pipe collar). Pipe has been upgraded from Non-Urgent to Urgent due to the wall deterioration near the outlet and an unknown condition through the levee. Levee is about 20 feet high. Recommend video inspection to determine pipe condition through the levee. This pipe is part of DWR's Deferred Maintenance Project (DMP), video inspection is expected to be completed next year for this crossing. (O. Magana - DWR UCIP)7/01/2016 WS slope appears to be stable; UCIP issue has been downgraded from Urgent to Non-Urgent due to what appears to be a stable slope--no other issues were observed during the site visit. The reason for the Non-Urgent classification is due to the limited documentation available to support extent of repair--need to obtain repair records to determine extent of repair and to determine if pipe was replaced through the levee. (DWR UCIP - omagana)4/29/2013 limited access; steep slopes, and dense vegetation; New riprap has been placed along pipe alignment need to contact owner to determine work authorization. Also need to find out if the design for riprap was due to slope failure at this location. This crossing is referenced in the USACE Periodic Inspection as item USACE_CESPK_HON1_2013_p_0246. (DWR UCIP - omagana)

View of WS slope covered with rip rap along pipe alignment.

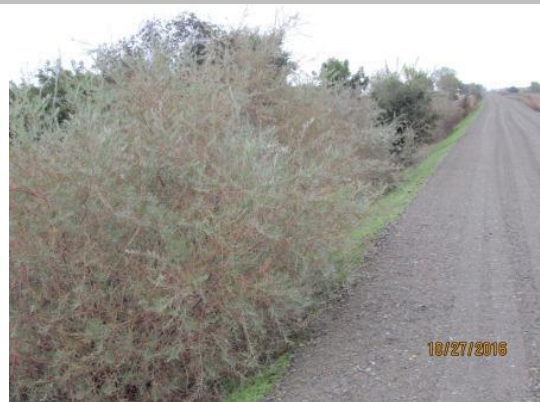
Photo 1 of 1 : SP_2019_RD0010_163_40_20190305_00004.jpg

View of willow trees on the landside slope looking upstream.

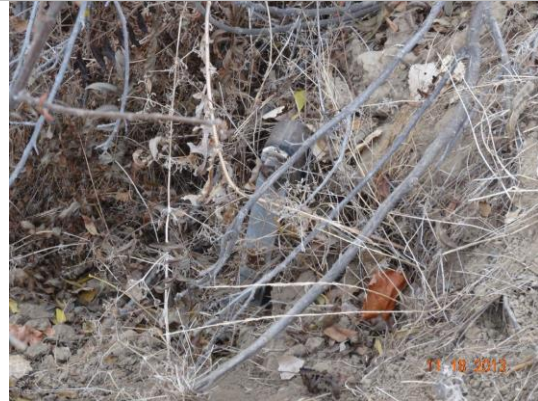
Photo 3 of 3 : UCIP_SP_2019_27533_51138.jpg

Buried flap gate on waterward side.

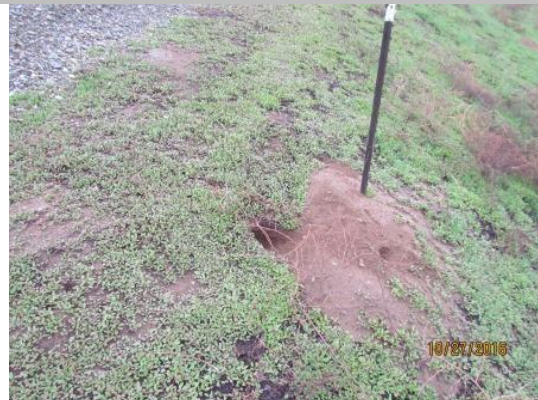
Photo 1 of 1 : SP_2019_RD0010_164_28_20190305_00003.jpg

View of squirrel hole on the waterside looking downstream.

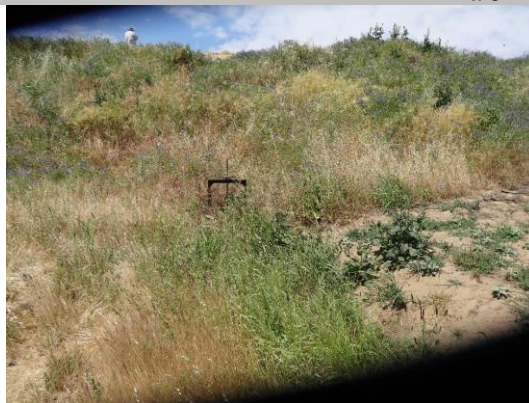
Photo 3 of 3 : UCIP_SP_2019_24751_44373.jpg

View of landward side--dense vegetation.

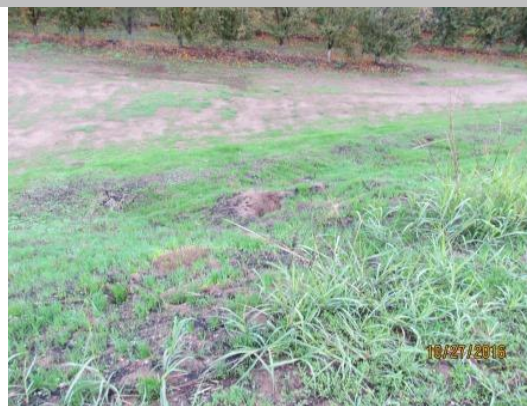
Photo 1 of 1 : SP_2019_RD0010_164_50_20190305_00018.jpg

View of rodent hole on landside slope.

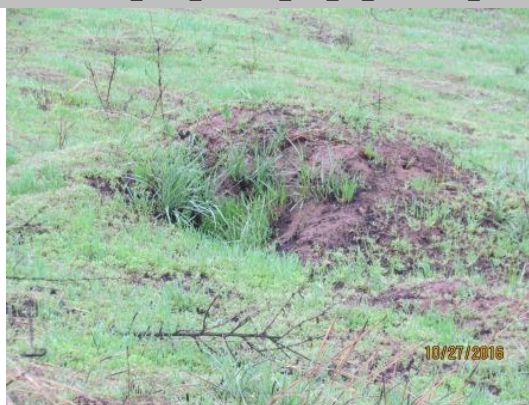
Photo 1 of 1 : SP_2019_RD0010_164_33_20190305_00009.jpg

View of rodent hole that has more than 2 cubic feet of material, this hole is not active but needs to be backfilled properly.

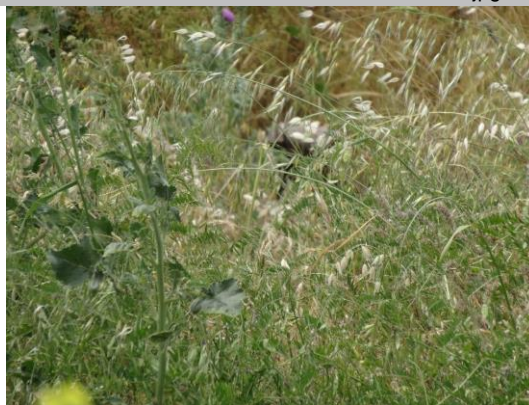
Photo 2 of 3 : UCIP_SP_2019_24768_44451.jpg

Dense vegetation on landward side.

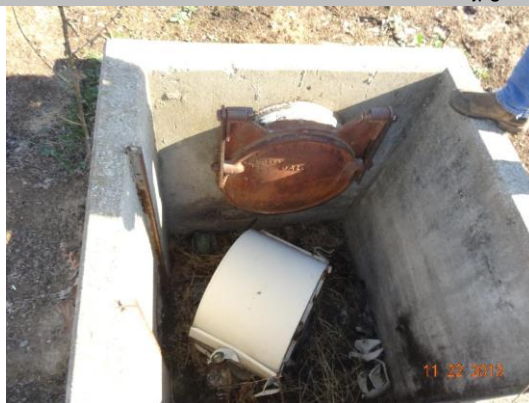
Photo 2 of 3 : UCIP_SP_2019_24769_44453.jpg

View of flap gate located inside concrete distribution box. Debris scattered inside box.

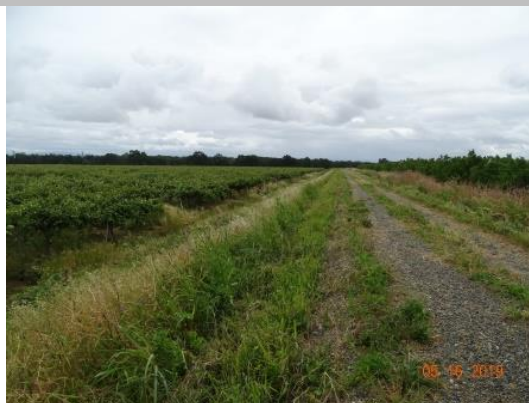
Photo 1 of 1 : SP_2019_RD0010_165_4_20190520_00014.jpg

View looking downstream at the landside of the annual vegetation that needs maintenance, Spring 2019.

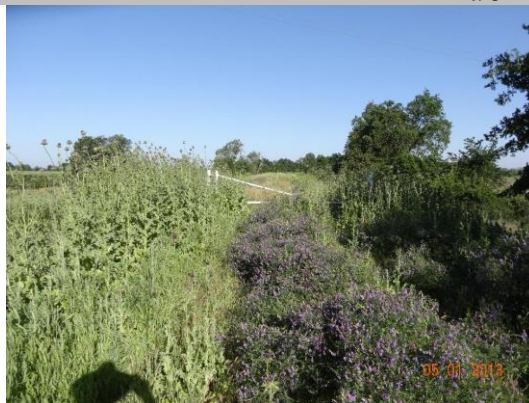
Photo 2 of 2 : UCIP_SP_2019_24883_44821.jpg

View of levee crown--dense vegetation.
